Environmental Health and Safety Institute Visit Report

College: Vance-Granville Community College
Location: Henderson, NC
Date of Visit: March 7-8, 2018
Visited By: Dave Martin – Adv. MESH, CESCO, Asbestos Accreditation
Primary Contact: Sean Newton

Main Campus Inspection March 7, 2018 (Pictures and locations are numbered, #)

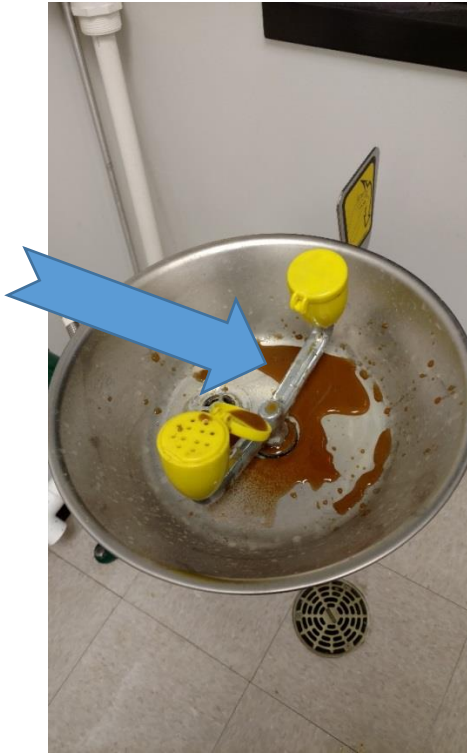
Location	Reference	Comments
Chem. Lab room 4202	29 CFR 1910.304(b)(i) and 1910.304(g)(6)(iv)(B)	Middle work bench the master GFCI doesn't reset.
Bldg. 8 room 8113 Pic #1	ANSI/ISEA Z358.1-2014	Eye wash by Biodiesel ran rusty water, should flush weekly.
* Bldg. 8 room 8110 and all other panels campus wide	1910.303(b)(1). 1910.303(b)(1)(vi) and NFPA 70E 2018	All electrical panels still need an arc flash analysis completed for each and the proper label affixed to the panels.
* Automotive 4105 and all other areas campus wide	1910.1200(g)(8) and 1910.1200	Many MSDS are still in the SDS notebooks. Request SDS (1 SDS found) from your suppliers for items you don't have SDS or go online to get them.
Bldg. 5 room 5210 A Pic # 2	1910.106(d)(1)(i) and (d)(3)	Prep room- a bottle of Ethanol should be in the flammable liquid storage cabinet. The gallon container maybe too large to fit the cabinet.

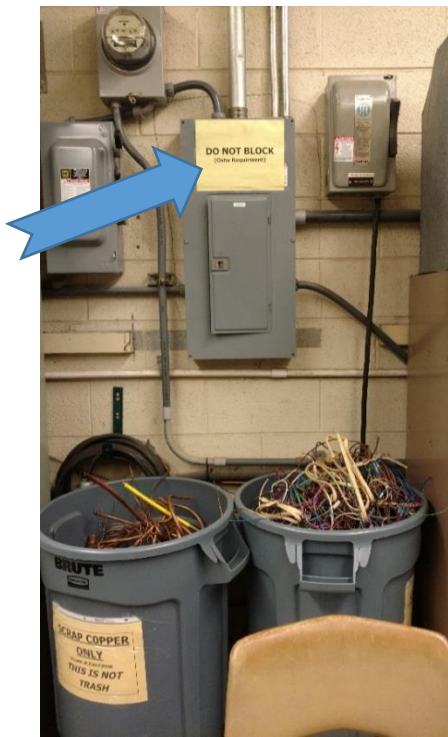
* Carpentry 5109	1910.212(a)(1) and 1910.212(a)(3)	Jet drill press needs a chuck guard.
HVAC room 5103 Pic #3	1910.303(g)(1)(i)(A) and 1910.303(g)(1)(i)(B)	Electric panel B is blocked by scrap copper wire containers.
HVAC room 5103 Pic #4	Check 1910.305(g)(1)(ii)(C) and the NEC	Yellow extension/flexible drop cords that go through the dropped ceiling- are they hard wired into a junction box and does that meet NEC standards?

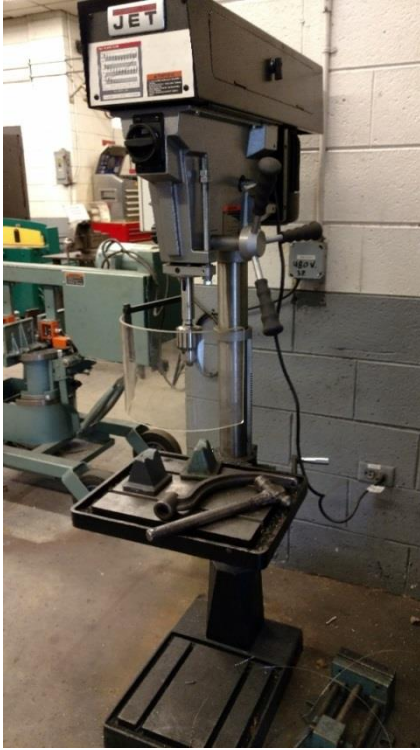
#5

- Welding room 3101 - a new chuck guard now on the Jet drill press (#5).
- All areas were clean and storage was in good condition.
- No slip, trip or fall hazards were noted.
- All fire extinguishers inspected were in good condition and current with the monthly inspection and the annual service.
- Room 5212 not inspected class in progress.

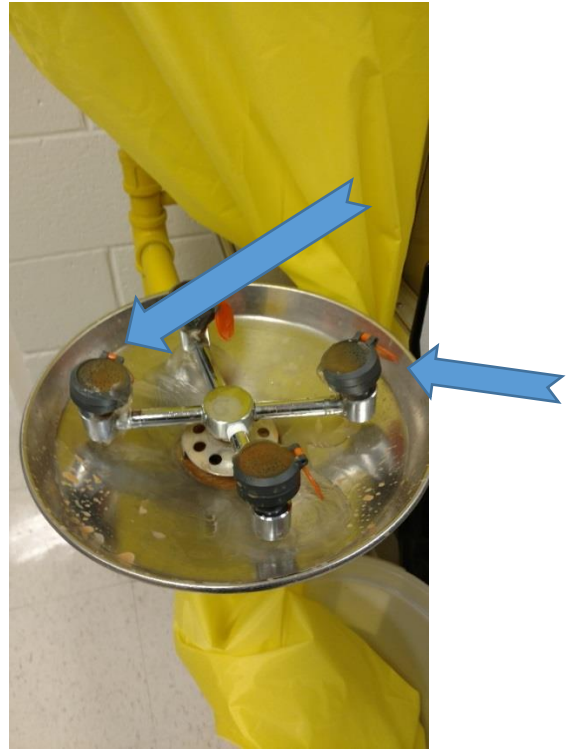
Location	Reference	Comments
Bldg.F3 rm F 3105 A #6	ANSI/ISEA Z358.1-2014	Eye wash ran rusty water, should be tested weekly and the testing recorded on the logs.
Bldg. F3 rm F 3105	29 CFR 1910.304(b)(i) and 1910.304(g)(6)(iv)(B)	Middle lab bench GFCI has an open ground, repair or replace the GFCI.

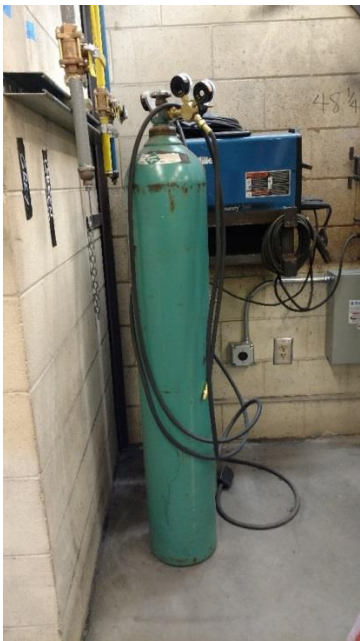
* Welding 2106	1910.212(a)(1) and 1910.212(a)(3)	Jet drill press needs a chuck guard.
Welding 2106 Pic #7	1910.253(b)(5)(O)	One Argon is free standing not secured to the wall.
Welding 2106	1910.22(b)	Mezzanine storage above room F 2106 A needs a load rating sign.
Welding F2106 Pic #8	1910.305(a)(2)(x)	Fan cord has no strain relief on the plug end needs repair.
Welding F2106 Pic #9	1910.157(c)(1), 1910.157(e)(2) and 1910.157(e)(3)	Fire extinguisher on the floor should be mounted and no tag to verify monthly inspection and annual service.
